Edge Deletion of Sputtered LoE® Coatings

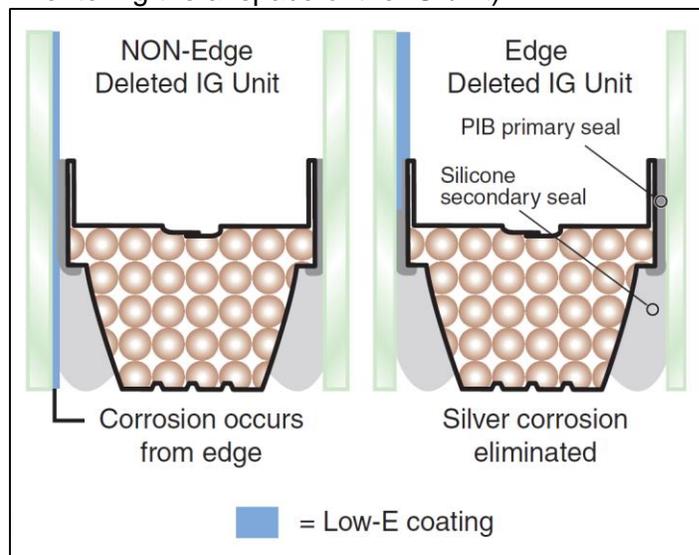
Fig. CG01-3: Edge deletion

As shown in Fig. CG01-3, corrosion occurs from the edge of the glass because the silver in the coating stack is completely exposed.

It is recommended Cardinal's LoE coating be completely deleted around the periphery of the glass, as shown in Fig. CG01-3. Since the LoE coating contains multiple coating layers, all layers should be removed to ensure adequate and consistent adhesion of the sealants. The coating should be deleted using an edge grinding technique that removes all of the coating down to the glass surface. The deletion should reach to a height that does not contact the sealant(s) or, in a dual-seal system, to a minimum of half the primary sealant height.

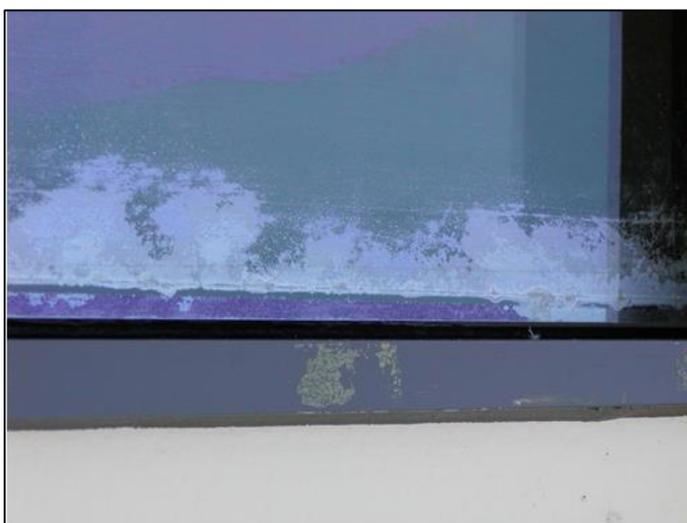
- Premature seal failure of the IG unit (caused by a splitting of the coating layers resulting in moisture entering the airspace of the IG unit)

Fig. CG01-2: Coating corrosion due to no edge deletion

Significant corrosion of the silver in the Low-E coating was visible after 4 weeks of this test. The failure mechanism involved corrosion beginning at the edge and then progressing into the silicone secondary seal, through the primary PIB seal and into the viewing area of the IG unit. The corrosion and failure mechanism are important because PIB sealants are considered to be the best IG sealant materials for resisting moisture permeation. Since the PIB primary seal did not stop the corrosion of the low-E coating, corrosion of low-E coatings will most likely occur with any other sealant material when exposed to the same test conditions.

These tests showed that corrosion of the silver can create the following anomalies:

- Visual obstruction in the daylight opening of the IG unit.
