Efflorescence: Cause and Control¹

**MASONRY
INSTITUTE OF
AMERICA**

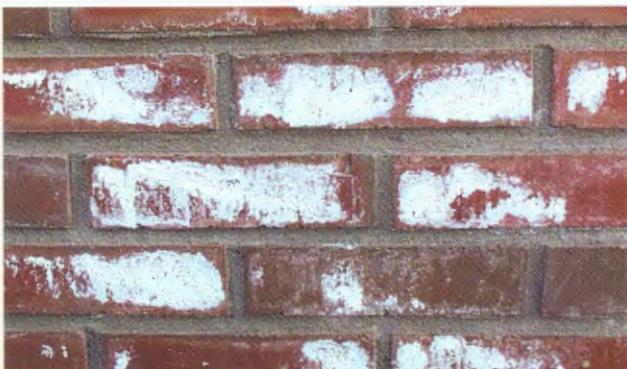
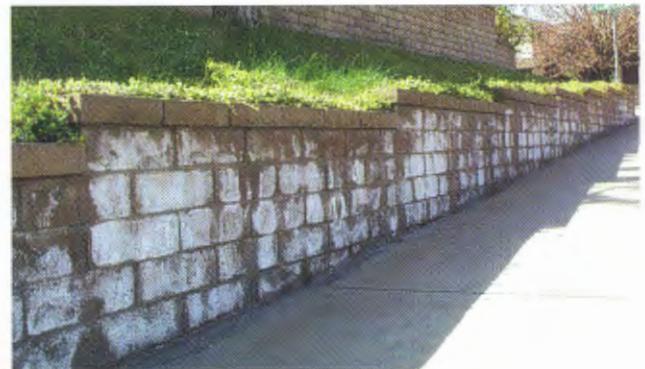
Figure 1. Typical white efflorescent salts on brick and block masonry

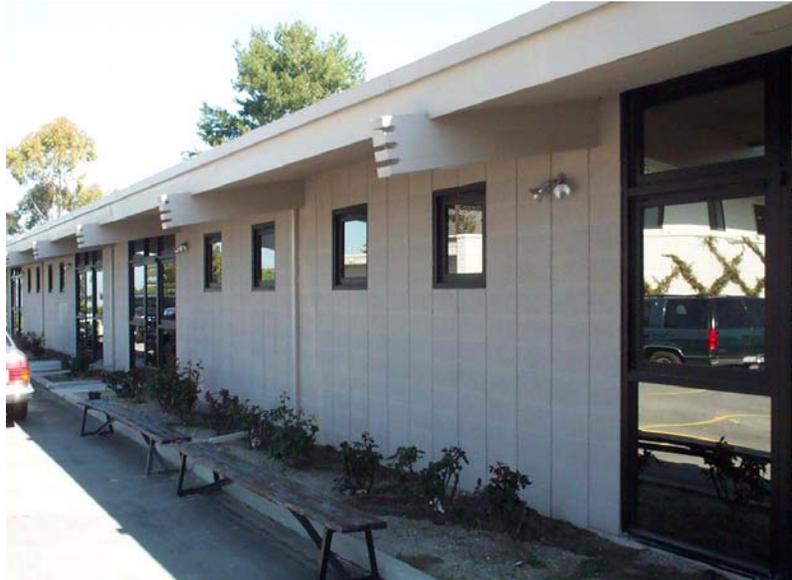
Figure 3. Overhanging eaves will help greatly to prevent moisture from entering this stack bond CMU wall.

The next critical concern is to prevent any water from penetrating into the masonry wall where it could cause efflorescence to occur. This can be done with good architectural details and quality masonry construction. Designing with overhanging eaves, copings and flashings, and careful attention to landscaping and sprinklers will reduce the chances of water entering the wall. In addition, specifying tooled, compacted mortar joints (concave or "V" type) will also reduce the potential for water infiltration. See Figures 3 and 4 for good efflorescence controlling design.

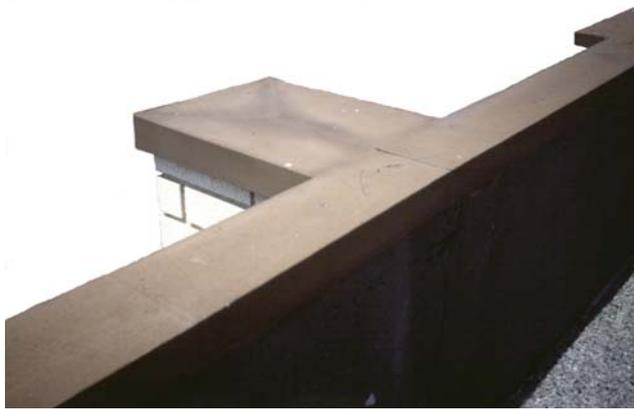
Figure 4. A full metal coping helps in waterproofing a wall and eliminates moisture penetration through the tops of parapets
