## TESTING THE GUARDRAIL POST TO DECK CONNECTION

Michael G. Morse and Daniel P. Walsh P.E.

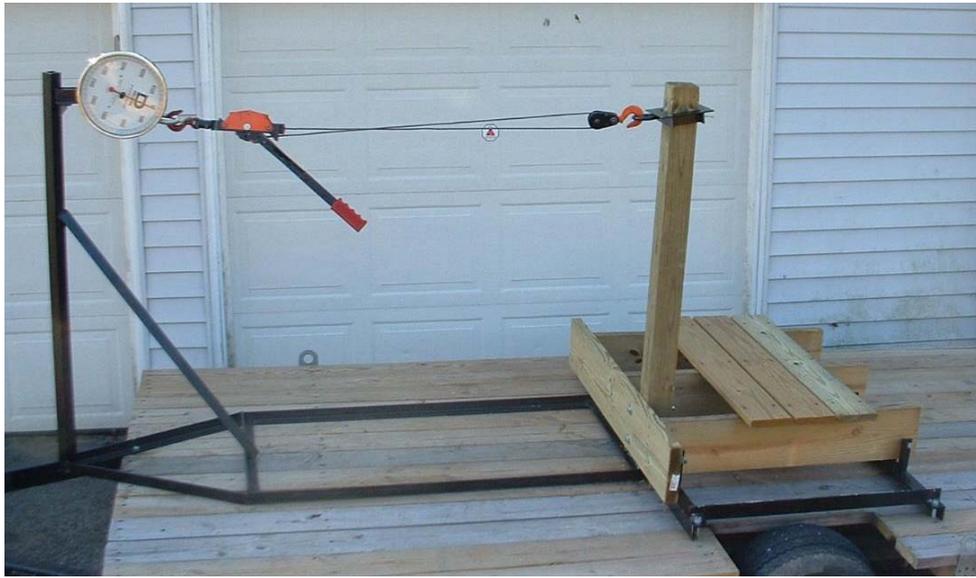
Photo 1: Test Load Frame

Our load frame was fabricated from 2" angle steel, welded into a 4'x5' rectangular test bed. By welding angle steel legs to the frame, slots were created to confine the deck joists. Holes were drilled through the steel slots where ½" pins would be inserted to lock the test units into the load frame. Steel risers were welded to the load frame to hold the test units above the frame. This allowed the guardrail post and the deck band board that was being tested to react and move independently without contacting or binding on the load frame itself. See photo 1.

Load was applied by means of a “come along” type cable puller with one end hooked to a calibrated and certified dynamometer and the other to a steel ring, affixed to the 4x4 timber post being tested. The ring was positioned at a height of 36" above the deck surface, the minimum height of a residential guardrail as required by IRC.

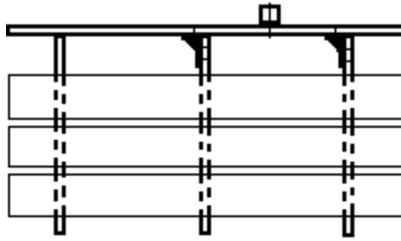
Diagram T-1

The configuration with DeckLok brackets is shown in Diagram T-1. The 4x4 post is mounted in identical fashion to the Control Test Unit. The DeckLok brackets were located with their base against the inside of the band board and their long side flush against a deck joist. The brackets were attached to the deck joists by two, 2½" long, ½" hex-bolts and nuts, with ½" flat washers on each side. A 2½" long, ½" hex-bolt, with flat washers and retaining nut secured the brackets to the band board. All nuts were tightened to approximately 30 lbs/ft of torque.

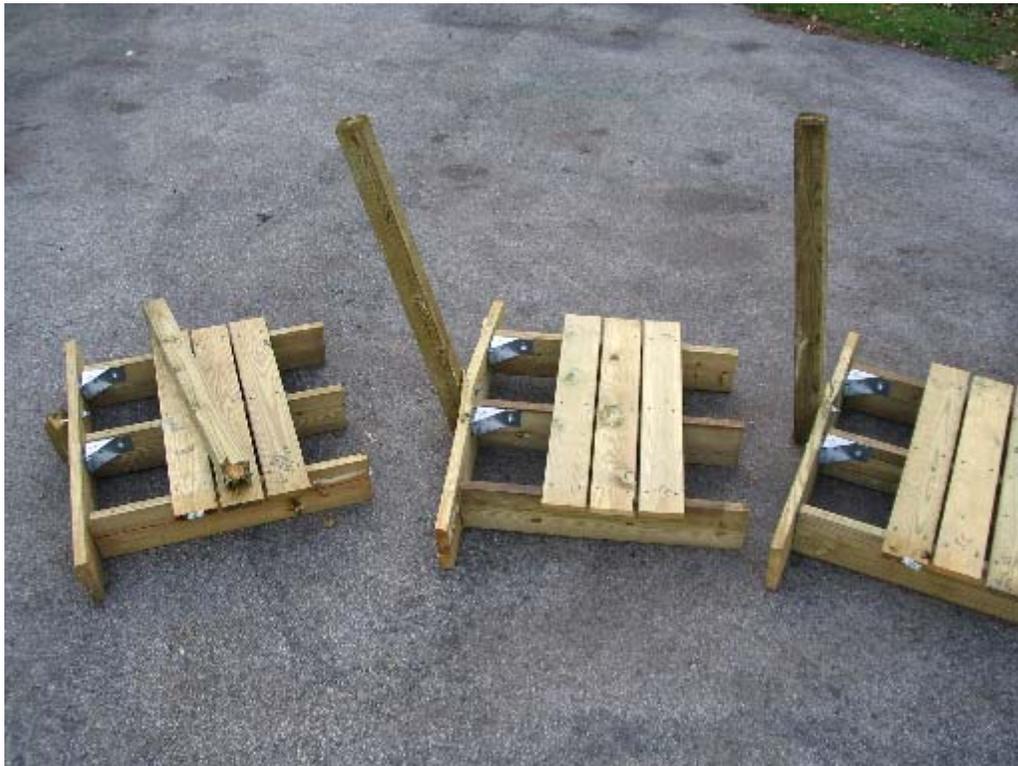
- 1A Timber failure of the 4x4 post at 700lbs
- 1B Timber failure of the band board at 525lbs
- 1C Timber failure of the band board at 600lbs

Test 1: Test units 1A, 1B, and 1C following test

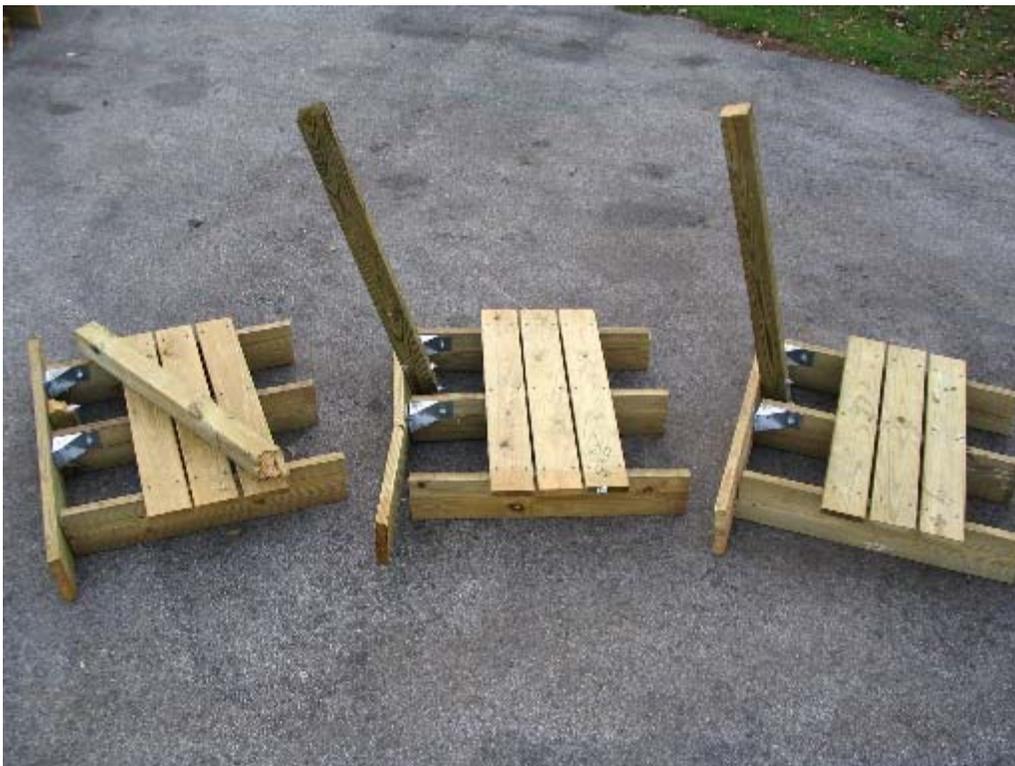
- 2A Timber failure of the 4x4 post at 525lbs
- 2B Timber failure of the band board at 525lbs
- 2C Timber failure of the band board at 500lbs

Test 2: Test units 2A, 2B, and 2C following test

It should be noted that there was an inconsistency in the load capacity of the 4x4 posts used in the testing. Each timber was examined carefully, picked for those with the fewest knots, cracks, or checking. However, the difference in their load strength was surprising. The 4x4 post from test 2A experienced total failure at 525 lbs, where a similar 4x4, bought from the same lot, on the same day, withstood 1325 lbs and did not fail. (the test was stopped to avoid damage to testing equipment and testing personnel).

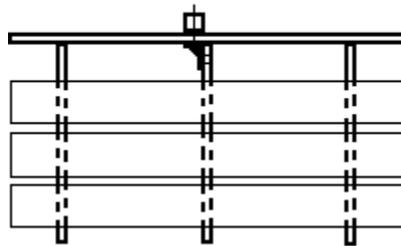
Diagram T-3

The DeckLok Bracket configuration for Test 3 is shown in Diagram T-3. One DeckLok bracket was utilized to anchor the 4x4, through the band board, to the deck joist by slipping the bracket over the top bolt and installing a flat washer and retaining nut. The DeckLok bracket was located with its base against the inside of the band board and the long side flush against a deck joist. The bracket was attached to the deck joist by two 2½" long, ½" hex-bolts and nuts, utilizing ½" flat washers on each side. All nuts were tightened to approximately 30 lbs/ft of torque.

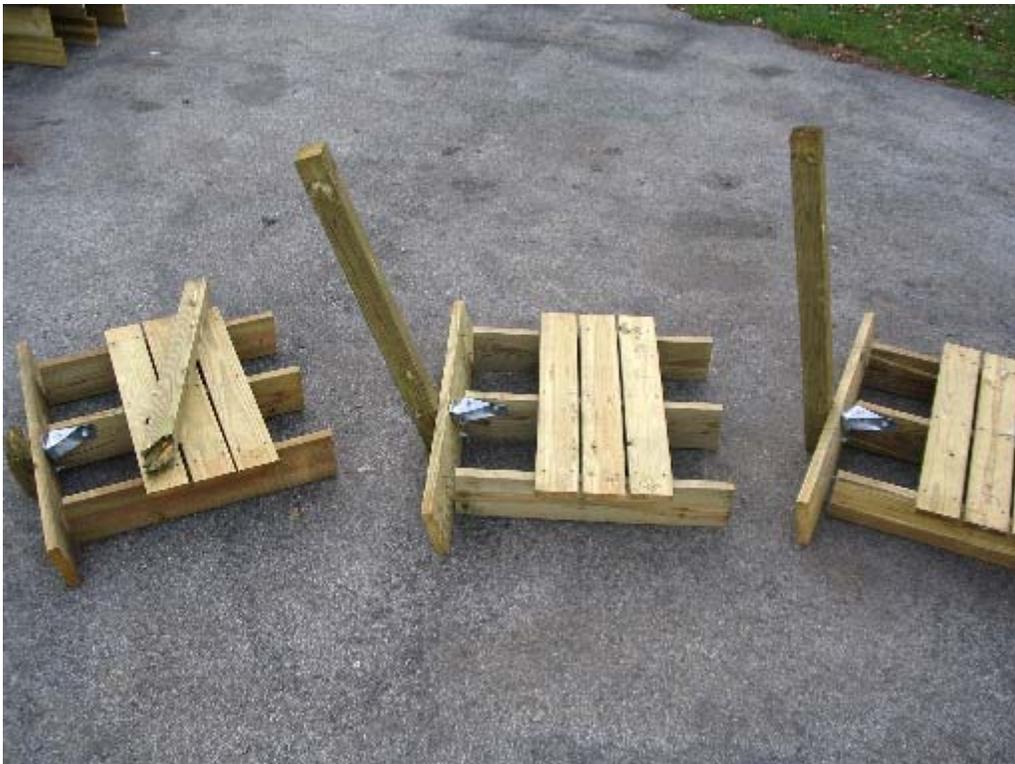
- 3A Timber failure of the 4x4 post at 600lbs
- 3B NO FAILURE Test stopped at 1,500 lbs to avoid damage to testing equipment.
- 3C NO FAILURE Test stopped at 1,350 lbs to avoid damage to testing equipment.

Test 3: Test units 3A, 3B, and 3C following test

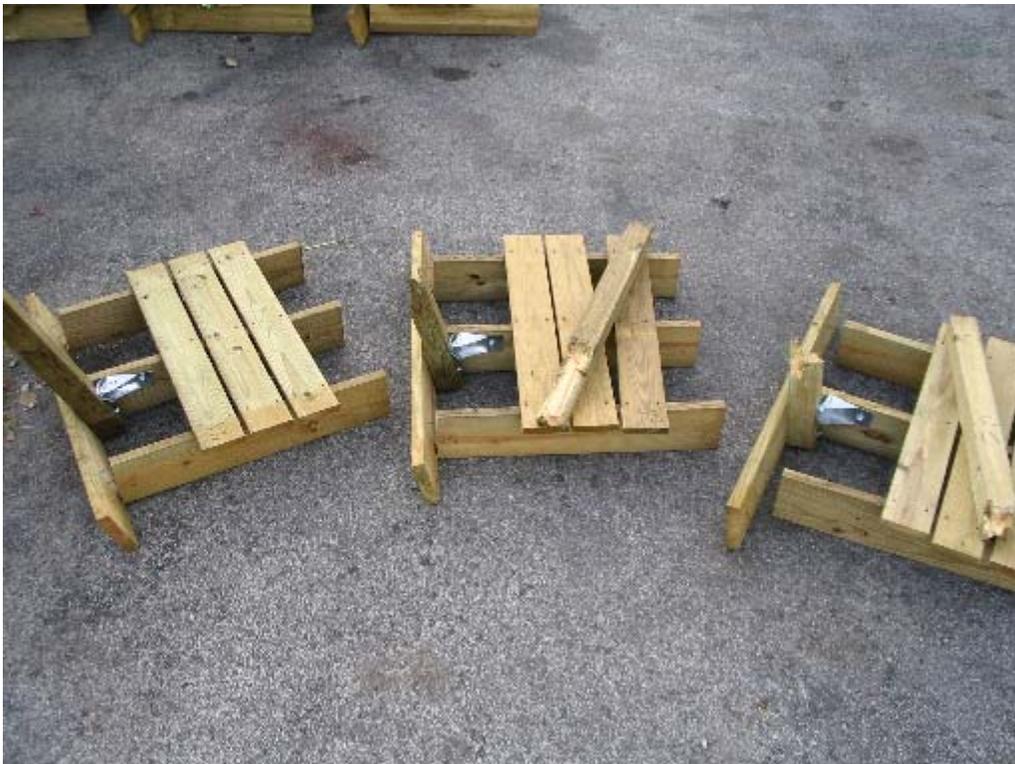
- 4A NO FAILURE Test stopped at 1,350 lbs to avoid damage to testing equipment.
- 4B Timber failure of the 4x4 post at 900 lbs. The dynamometer jumped to 1,400 lbs indicated when 4x4 broke.
- 4C Timber failure of the 4x4 post at 525 lbs.

Test 4: Test units 4A, 4B, and 4C following test

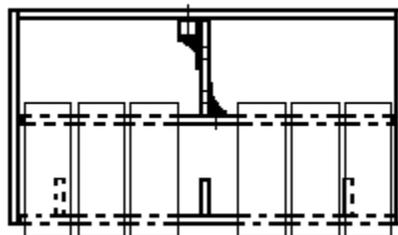
Diagram T-5

The DeckLok Bracket configuration for Test 5 is shown in Diagram T-5. One DeckLok bracket was located with its base against the inside of the 4x4 and the long side flush against the 2x8 blocking. The second bracket was located with its base against the deck joist and the long side flush against the 2x8 blocking. The brackets were attached to the 2x8 blocking by two, 2½" long, ½" hex-bolts and nuts, utilizing ½" flat washers on each side. A 2½" long, ½" hex-bolt, with flat washers and retaining nut secured the brackets to the deck joist and the 4x4. All nuts were tightened to approximately 30 lbs/ft of torque. As in the other tests, the 5/4" board deck tread was screwed to the deck joists that were not in contact with the 4x4 post.

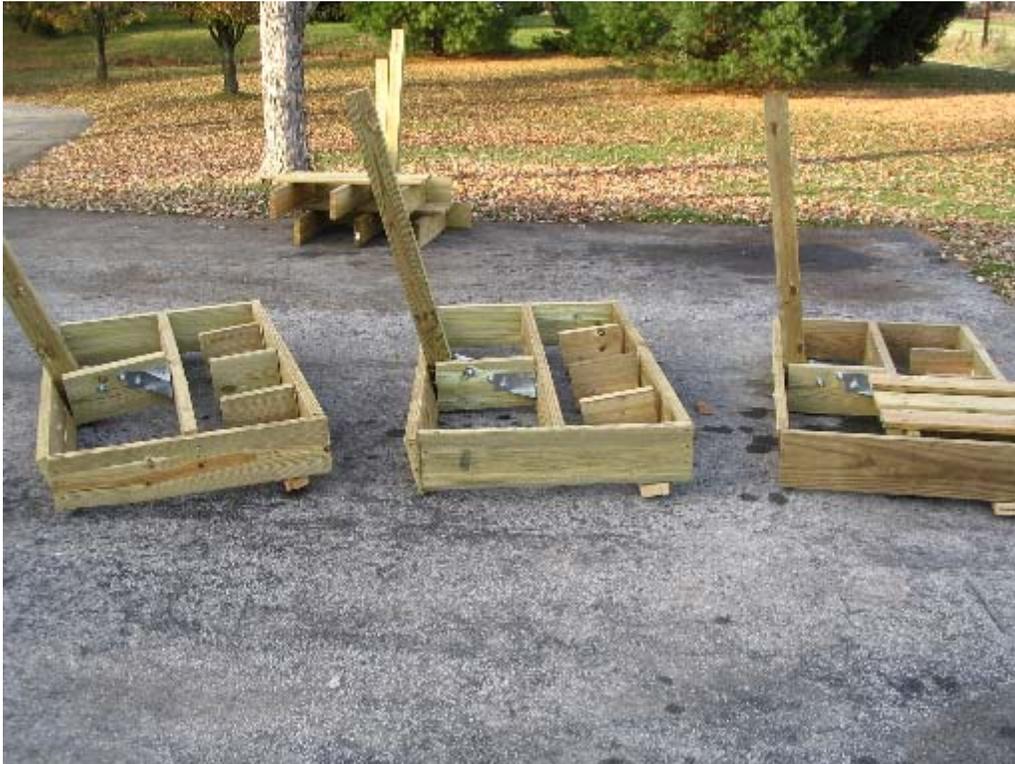
- 5A NO FAILURE Test stopped at 1,350 lbs to avoid damage to testing equipment
- 5B NO FAILURE Test stopped at 1,500 lbs to avoid damage to testing equipment.
- 5C NO FAILURE Test stopped at 1,350 lbs to avoid damage to testing equipment.

Test 5: Test units 5A, 5B, and 5C following test
